**Flood Control Project Maintenance
Levee Inspections**

Maintenance Issue Types Only, Levee Inspection Report By Mile - Fall 2015

Reclamation District No. 0341 Sherman Island

Waterway	Bank	Unit Miles	Inspection Start/End	Inspector
Unit No. 01 Threemile Slough	Right	3.36	10/08/2015 10/08/2015	Herman Phillips

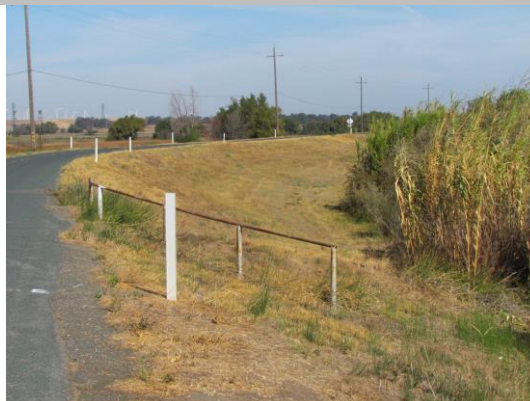
Photo 1 of 1 : FA_2015_RD0341_167_23_20151008_00013.jpg

LM Start	0.01	Rating **	A	Issue No.	23
LM End	1.95	Issue Type +	Ma	Location *	WS
Category	Earthen Levee			GPS Latitude/Longitude	
				Start	End
Item	Vegetation			38.085668 °	38.113412 °
				-121.686523 °	-121.684058 °
DWR ID	DWR_RD0341_01_f_2015_23				
Action/Comments					
Control annual grass and weeds on the levee slopes and easements. Inspector Comments: No unwanted vegetation.

RD 341 Looking downstream from levee mile 0.00 at mowed levee slope. The arundo has been sprayed.

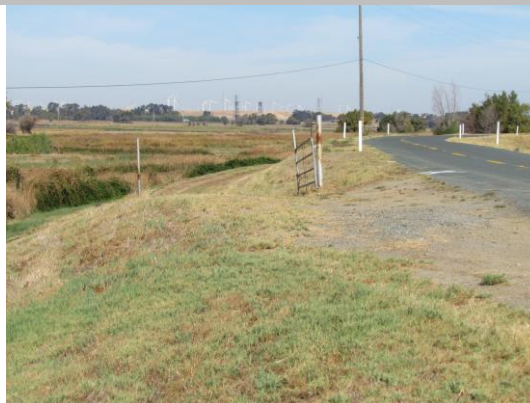
Photo 1 of 1 : FA_2015_RD0341_167_24_20151008_00014.jpg

LM Start	0.01	Rating **	A	Issue No.	24
LM End	3.33	Issue Type +	Ma	Location *	LS
Category	Earthen Levee			GPS Latitude/Longitude	
				Start	End
Item	Vegetation			38.085668 °	38.105183 °
				-121.686523 °	-121.702030 °
DWR ID	DWR_RD0341_01_f_2015_24				
Action/Comments					
Control annual grass and weeds on the levee slopes and easements. Inspector Comments: No unwanted vegetation present on slope.

RD 341 Looking downstream from levee mile 0.01 slopes has been mowed to levee mile 3.33.

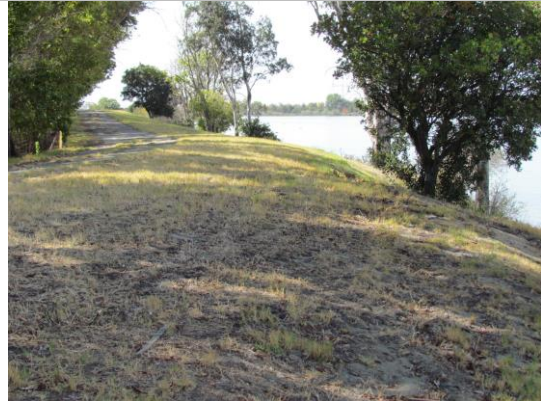
Photo 1 of 1 : FA_2015_RD0341_168_2_20151008_00021.jpg

LM Start	3.34	Rating **	M	Issue No.	2
LM End	3.37	Issue Type +	Ma	Location *	WS
Category	Earthen Levee			GPS Latitude/Longitude	
				Start	End
Item	Vegetation			38.105130 °	38.105313 °
				-121.702000 °	-121.702713 °
DWR ID	DWR_RD0341_02_f_2014_2				
Action/Comments					
Remove the wild growth other than native grasses from the levee slopes.

RD 341 Unit 2 looking downstream from levee mile 3.34 -3.37 waterside.

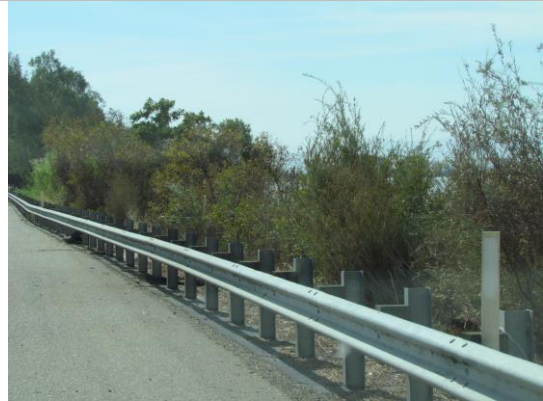
Photo 1 of 1 : FA_2015_RD0341_168_45_20151008_00023.jpg

LM Start	3.97	Rating **	U	Issue No.	45
LM End	6.19	Issue Type +	Ma	Location *	WS
Category	Earthen Levee			GPS Latitude/Longitude	
				Start	End
Item	Vegetation			38.097763 °	38.080573 °
				-121.706288 °	-121.731113 °
DWR ID	DWR_RD0341_02_f_2015_45				
Action/Comments					
Remove the wild growth other than native grasses from the levee slopes. Inspector Comments: The unwanted vegetation on the waterside needs spraying or mowing. The arundo present blocks view of the levee section.

Looking downstream from the waterside slope unwanted vegetation shoulder and slope.

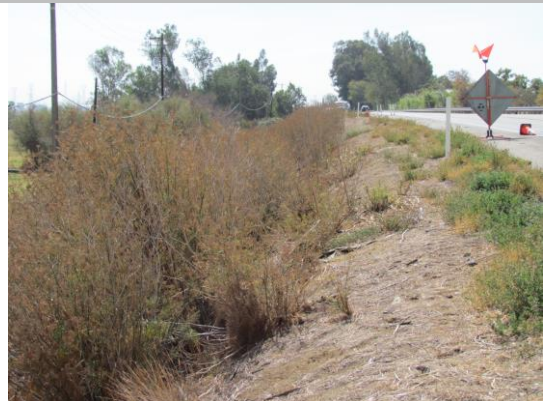
Photo 1 of 1 : FA_2015_RD0341_168_46_20151008_00024.jpg

LM Start	3.97	Rating **	U	Issue No.	46
LM End	6.15	Issue Type +	Ma	Location *	LS
Category	Earthen Levee			GPS Latitude/Longitude	
				Start	End
Item	Vegetation			38.097763 °	38.080323 °
				-121.706287 °	-121.730453 °
DWR ID	DWR_RD0341_02_f_2015_46				
Action/Comments					
Control annual grass and weeds on the levee slopes and easements. Inspector Comments: Remove the wild vegetation from the landside slope.

Looking downstream from the landside at tall anise weeds on the slope and toe.

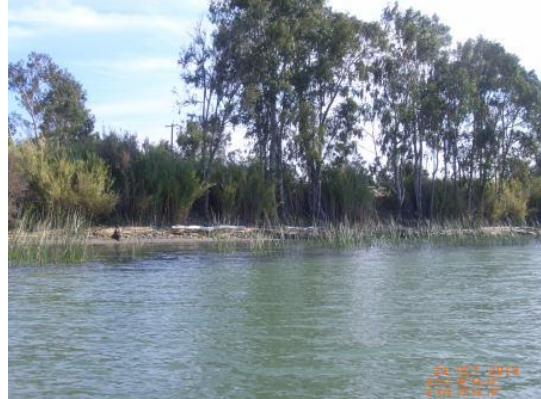
Photo 1 of 1 : USACE2013A_SAC_8-2_L_2.jpg

LM Start	4.15	Rating **	M	Issue No.	7
LM End	4.19	Issue Type +	Ma	Location *	WS
Category	Supplemental			GPS Latitude/Longitude	
				Start	End
Item	2015 USACE Erosion Survey, DRAFT			38.095148 °	38.094590 °
				-121.706367 °	-121.706393 °
DWR ID					
Action/Comments					
Inspector Comments: 2011 - Large new erosion pocket probably hidden by vegetation in the past. 2015: No observed changes. [2015 Site ID: SAC_8-2_L]

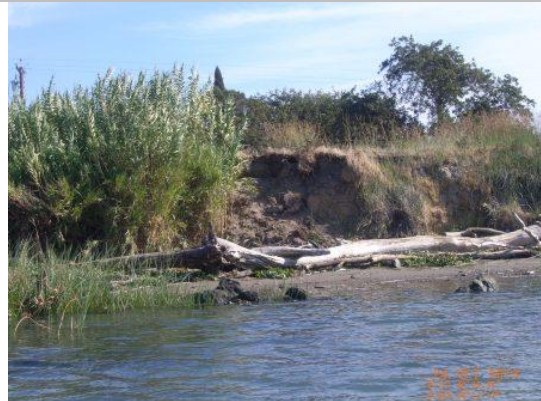
Photo 1 of 1 : USACE2013A_SAC_8-0_L_2.jpg

LM Start	4.47	Rating **	U	Issue No.	3
LM End	4.62	Issue Type +	Ma	Location *	WS
Category	Supplemental			GPS Latitude/Longitude	
				Start	End
Item	2015 USACE Erosion Survey, DRAFT			38.090620 °	38.088572 °
				-121.706684 °	-121.707127 °
DWR ID					
Action/Comments					
Inspector Comments: 1999 - New small slump in eroded bank. 2005 - Reach extended because of vertical bank along the roadway upstream. 2011 - More slumping since last year. 2012 - Site upgraded to critical. Very steep slope which may be effecting the highway on top of the levee. 2015: New erosion towards downstream end of site. [2015 Site ID: SAC_8-0_L]

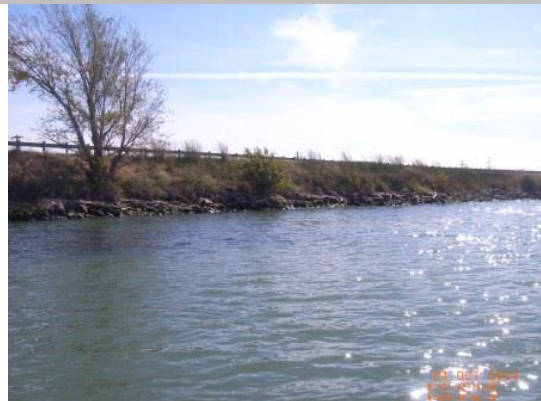
Photo 1 of 1 : USACE2013A_SAC_7-9_L_1.jpg

LM Start	4.76	Rating **	U	Issue No.	4
LM End	4.85	Issue Type +	Ma	Location *	WS
Category	Supplemental			GPS Latitude/Longitude	
				Start	End
Item	2015 USACE Erosion Survey, DRAFT			38.086603 °	38.085459 °
				-121.707786 °	-121.708607 °
DWR ID					
Action/Comments					
Inspector Comments: 2011 - Large slump section. 2012 - Site extended downstream, upgraded to critical, severe windwave. Slope is very steep and may be effecting the highway on top of the levee. 2015: No observed changes. [2015 Site ID: SAC_7-9_L]

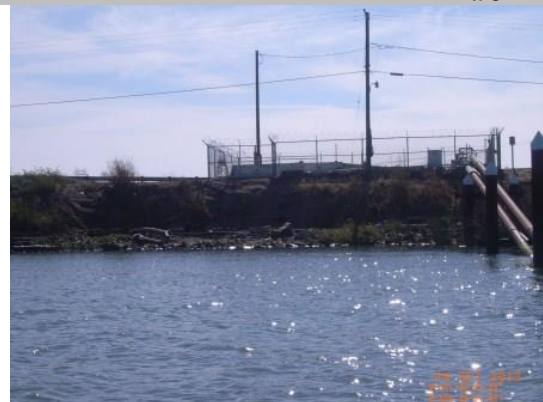
Photo 1 of 1 : USACE2013A_SAC_7-3_L_3.jpg

LM Start	6.03	Rating **	U	Issue No.	1
LM End	6.16	Issue Type +	Ma	Location *	WS
Category	Supplemental			GPS Latitude/Longitude	
				Start	End
Item	2015 USACE Erosion Survey, DRAFT			38.080370 °	38.080526 °
				-121.728341 °	-121.730483 °
DWR ID					
Action/Comments					
Inspector Comments: 2011 - Large slump at downstream end. Gully formed from surface runoff from the road. Shallow slumping throughout site. 2012 - The gully at upstream end has increased in size and site continues to worsen. 2015: No observed changes. [2015 Site ID: SAC_7-3_L]

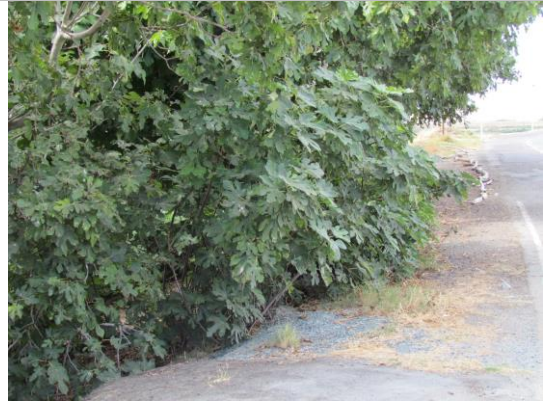
Photo 1 of 1 : FA_2015_RD0341_168_47_20151008_00025.jpg

LM Start	6.29	Rating **	U	Issue No.	47
LM End	6.32	Issue Type +	Ma	Location *	LS
Category	Earthen Levee			GPS Latitude/Longitude	
				Start	End
Item	Trim / Thin Trees			38.081075 °	38.081142 °
				-121.732813 °	-121.733465 °
DWR ID	DWR_RD0341_02_f_2015_47				
Action/Comments					
Trim trees to at least five feet above ground level. Inspector Comments: Remove the unwanted fig trees from the levee section.

Landside slope blocked by woody growth of fig trees.
